Appendix E: Waters of the U.S.

The Central Utah Rail Project (CURP) proposes to construct and operate about 43 miles of new rail line and related rail facilities to connect shippers in the Sevier Valley to mainline rail service.

The purpose of this technical report is to present the results of field evaluations of previously identified potential jurisdictional waters of the U.S. in the CURP corridor.

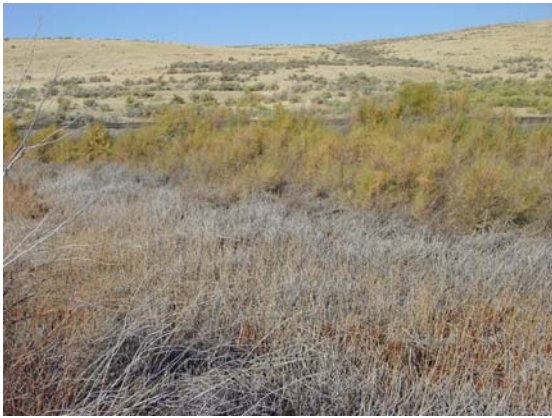
Photo #1
Data point #1

Data point #1 was taken down near the Chicken Creek area. It is documented as GPS waypoint #227. The site is located between SR 78 and the existing railroad tracks. The hydrological source appears to be from impounded storm event sheet flow. No culverts under the highway could be visually identified. Photos #1 and #2 were taken at data point #1. Soil under an alkali crust was saturated to the surface. Dominant vegetation was hydrophytic, somewhat tolerant of saline, and indicative of riparian areas. These species included *Tamarix ramosissima* (salt-cedar), *Scirpus acutus* (hard-stem bulrush), *Distichlis stricta* (inland saltgrass), and *Salix exigua* (coyote willow).

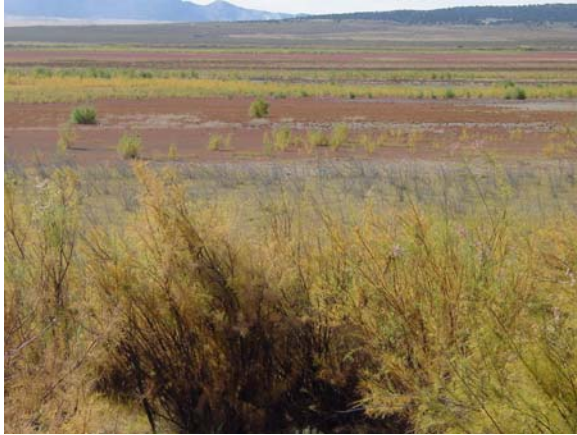
Photo #3
Data point #2

Data point #2 was taken about 0.5 mile northeast of point #1. The GPS waypoint is #228. The photographs were oriented toward the east. As at data point #1, this vegetation also appears to be tolerant of salinity and indicates a riparian zone. However, the field biologist believed the area to be different enough to warrant a separate data point. It is east of the highway and appears to be hydrologically supported by various springs in the area. Vegetation observed includes salt-cedar and inland saltgrass. Additionally, in wetter years, this area probably receives some hydrologic support from precipitation runoff. Data point #2 is shown in photos #3 and #4.

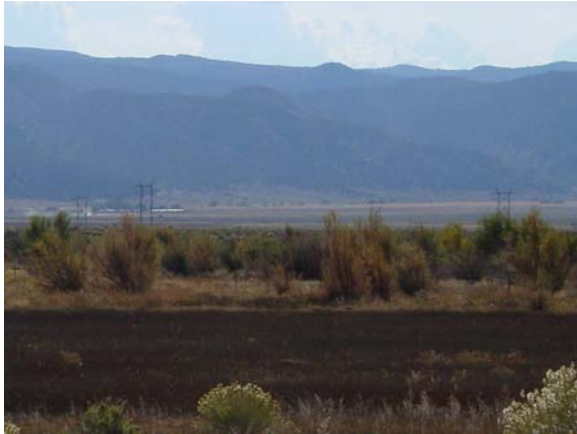
Photo #5
Data point #3

Data point #3 appears to be a wet meadow with some species that suggest saline tolerance. Data point #3 was taken about 1 mile north of data point #2. The GPS waypoint is #229. Photographs #5 and #6 were oriented toward the east to southeast. This site appears to be on the northern fringe of Chicken Creek Reservoir. Vegetation is mainly *Juncus balticus* (wiregrass) with some salt-cedar and inland saltgrass. Hydrologic support appears to be in the form of springs and precipitation runoff.

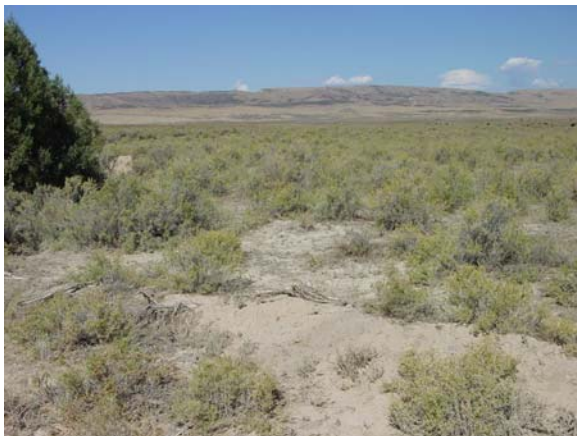
Photo #7
Data point #4

Data point #4 is located in an upland area with a single culvert that conveys intermittent precipitation runoff under the graded dirt road. Vegetation present is *Sarcobatus vermiculatus* (greasewood), *Artemesia tridentata* (big sagebrush), *Atriplex canescens* (fourwing saltbush), and *Bromus tectorum* (cheatgrass). The GPS waypoint is #230. Photographs #7 and #8 show the vegetation type present. This data point is almost directly under the large power transmission lines.

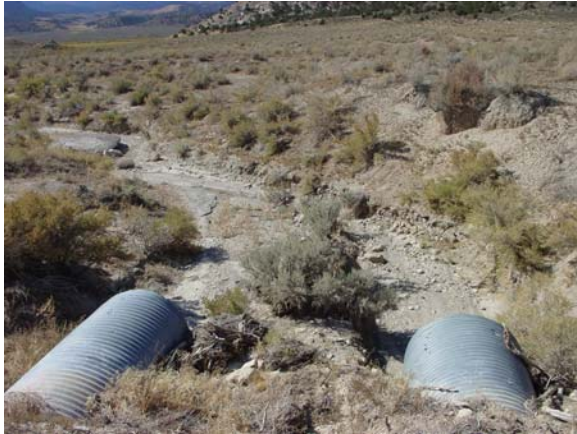
Photo #9
Data point #5

Data point #5 is shown in photographs #9 (oriented looking south) and #10 (oriented looking north). The GPS waypoint is #231. The data point is at an ephemeral drainage that is an unnamed tributary to the Sevier Bridge Reservoir. The drainage has twin pipe culverts that convey intermittent precipitation runoff under the graded dirt road. The site is located about 0.5 mile from the reservoir. Dominant vegetation consists of greasewood, cheatgrass, big sagebrush, *Salsola iberica* (Russian thistle), and *Halogeton glomeratus* (halogeton).

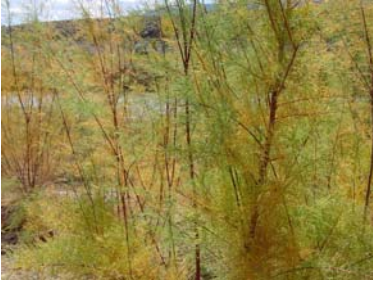
Photo #11
Data point #6

Data point #6 is situated at a narrow portion of the Sevier River Reservoir where the large overhead power lines cross over the water. The GPS waypoint is #232. Photographs #11, #12, and #14 show the existing vegetation and physical setting. Photos #11 and #12 show views near the channel of the Sevier River, well below the ordinary high-water mark. Photo #14 was taken from the same location as #12, but shows the ordinary high-water mark (OHWM) and associated vegetation at the OHWM interface. The dominant vegetation near the river channel consists mainly of salt-cedar and *Carex* spp. (sedges). The vegetation near the OHWM is dominated by big sagebrush, *Chrysothamnus nauseosus* (rubber rabbitbrush), and *Gutierrezia sarothrae* (broom snakeweed).

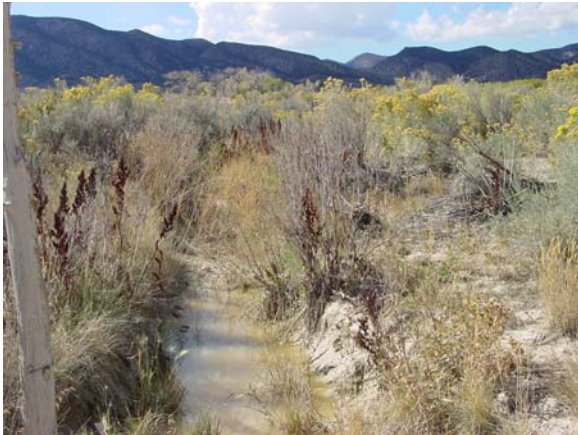
Photo #15
Data point #7

Data point #7 was taken at a location that appeared on the USGS map to be an ephemeral drainage. The GPS waypoint is #233. Photographs #15 and #16 show the setting. The location where the proposed rail corridor would cross this particular drainage is about 0.25 mile to the west. Because the proposed corridor is west of the data point, both photos are oriented to the west to better show the existing conditions. The area around this ephemeral drainage appears to have been disturbed by agricultural practices. Any natural bed and bank development appears to have been channelized. Along the channel, a line of *Populus freemontii* (Freemont's cottonwood) were observed. Other dominant species at the site include rubber rabbitbrush and big sagebrush.

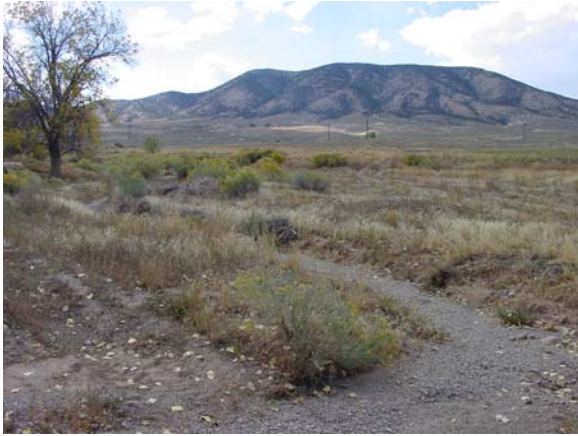
Photo #17
Data point #8

Data points #8 and #9 represent similar site conditions at an ephemeral drainage. These data points are GPS waypoints #234 and #235, respectively. These areas also appear to be disturbed agricultural areas. The dominant vegetation consists of rubber rabbitbrush, cheatgrass, *Agropyron cristatum* (crested wheatgrass), Russian thistle, and Fremont’s cottonwood (at site #8). These two sites are shown in photographs #17 through #20.

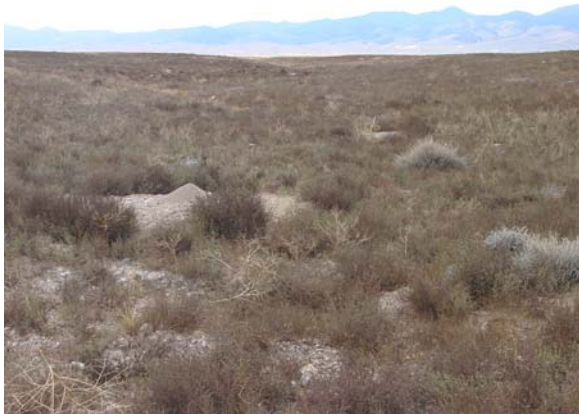
Photo #21
Data point #10

Data point #10 is also at an ephemeral drainage in an agricultural area. This site appears to have burned recently. The dominant vegetation is Russian thistle. This site appears very disturbed with very little remnant native vegetation. The GPS waypoint is #236. Photographs #21 and #22 show the extent of Russian thistle invasion.

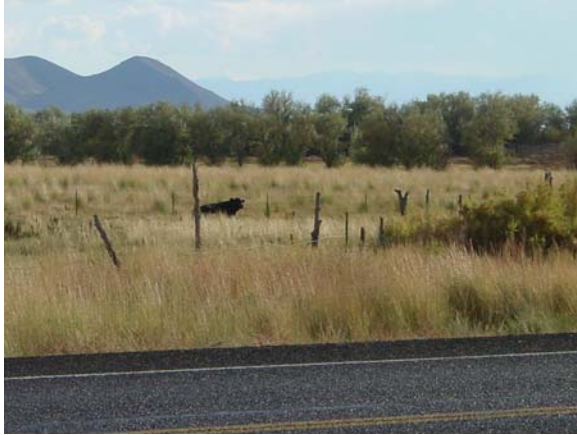
Photo #23
Data point #11

Data point #11 is located at the point at which Alternative A of the proposed rail line would intercept SR 50 and Denmark Wash. Denmark Wash, a tributary of the Sevier River, is conveyed under the north-south-oriented road through twin box culverts. The GPS waypoint is #237. Photographs #23 and #24 show the setting of the site. Photograph #23 is oriented to the south, and the eastbound lane of SR 50 can be seen in the foreground. Photograph #24 is oriented to the north and is more indicative of the type of vegetation surrounding Denmark Wash. This vegetation is mainly salt-cedar, coyote willow, and *Kochia scoparia* (summer cypress).

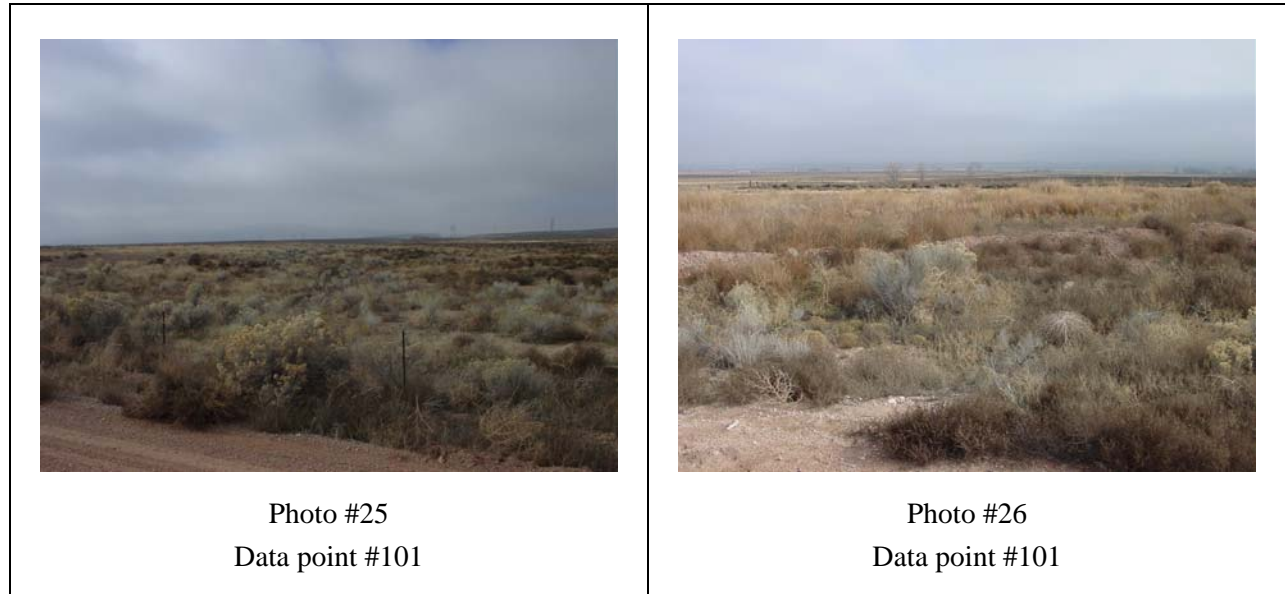
Data point #101 is located adjacent to the Piute Canal about 0.75 mile north of SR 50. The GPS waypoint is #239. Photographs #25 and #26 show the setting of the site. Photograph #25 is oriented to the south, #24 to the north. The vegetation is mainly aggressive invaders: cheatgrass, Russian thistle, and broom snakeweed with some desirable shrubs such as rubber rabbitbrush. Data points #102, #103, #104, and #105 are all similar enough to data point #101 that they do not require itemized documentation.

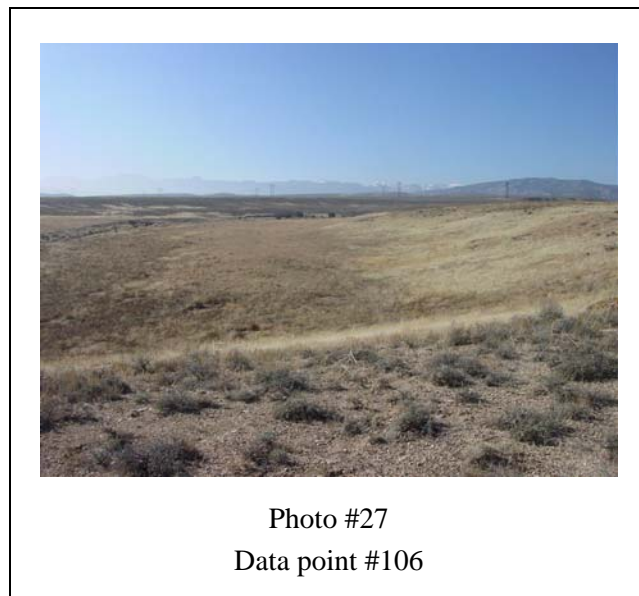
Data point #106 has a bed and bank development that is about 3 meters wide. Photo #27 is from a somewhat elevated position; the orientation is south-southeast and shows how wide the overall swale appears to be. The dominant vegetation is big sagebrush, rubber rabbitbrush, broom snakeweed, *Sisymbrium altissimum* L. (tumbling mustard), and cheatgrass.

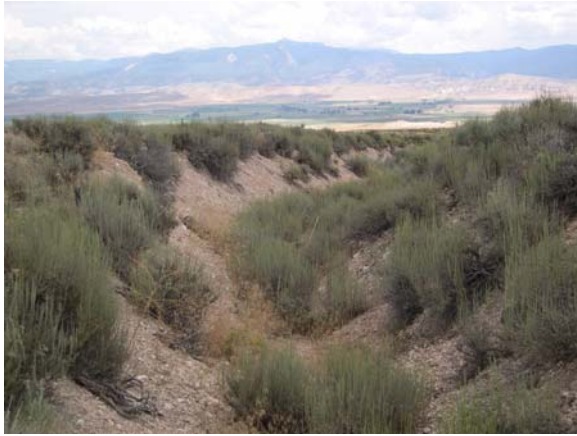
Photo #28
Data points #201– #210

Data points #201 through #210 are all very similar in nature and character to data points #101 through #105. The areas are generally disturbed, either by fire or by human development. The general vegetation is consistent with other ephemeral drainages in the project area. Dominant vegetation includes big sagebrush, rubber rabbitbrush, low rabbitbrush, broom snakeweed, Indian ricegrass, cheatgrass, Russian thistle, tumbling mustard, and the occasional saltbush. Representative photos of these areas are photographs #28 and #29.
